Minerals Inspection Report

Report Date: 07/02/2014

Mine Name: Topaz	Permit Number: M/023/0003	Mine Status: Active
Operator Name: Materion Natural Resources	Inspection Date: 06/26/2014	Permit Fees: Paid
Inspector(s): Wayne Western	Inspection Time: 9:00 - 10:15 am	Bond Amount: \$1,398,000
Attendee(s): Rob Dalton	Weather: overcast mild	Bond Escalation: 12/01/2016
Inspection Purpose: Routine inspection		Prior Inspection: 05/16/2013

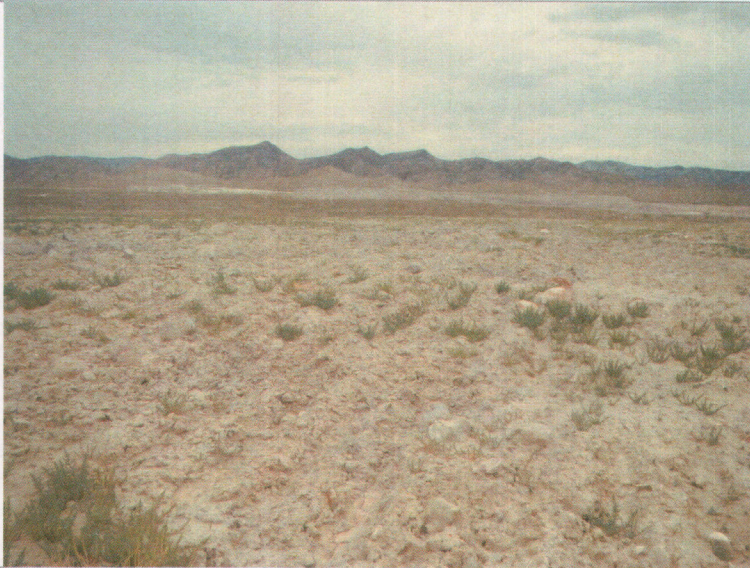
6. Reclamation The Monitor Phase 1 dump top area had be backfilled and graded last year. The site met the minimum standards for reclamation.	<input checked="" type="checkbox"/>	<input type="checkbox"/>

9. Revegetation There was some vegetation on the Monitor Phase 1 dump top area.	<input checked="" type="checkbox"/>	<input type="checkbox"/>
10. Other	<input type="checkbox"/>	<input type="checkbox"/>

Reclaimed area looking west. Notice some plants has started to grow.

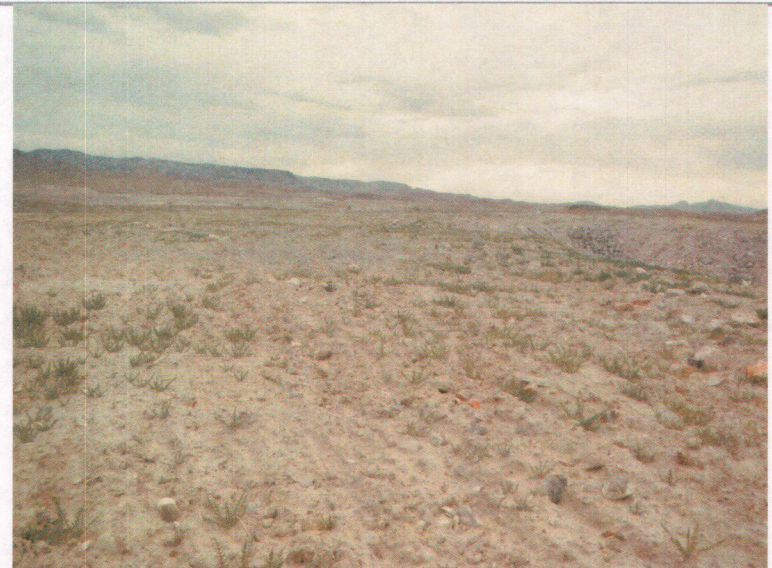
Reclaimed area looking west

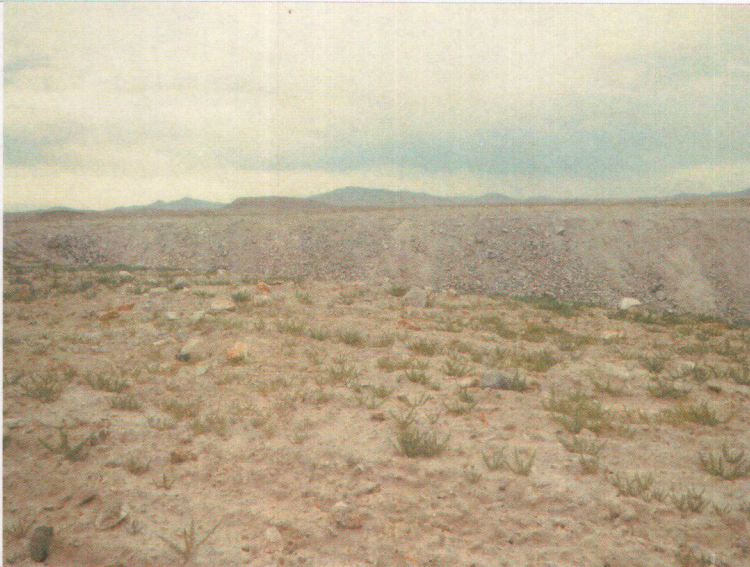
Reclaimed area east side

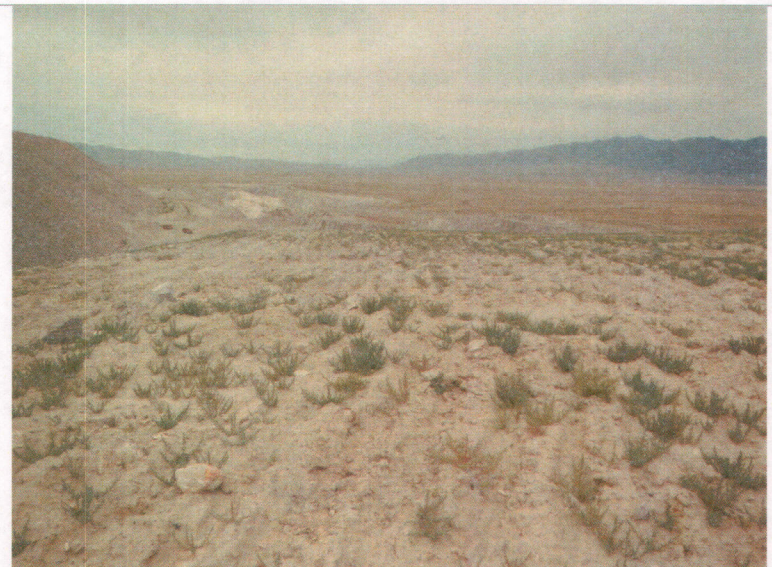
Reclaimed area east side
